Subject: 2010300074 - Winnebago County  
Soil Component Remedial Action Completion Report  
Source Area 4, Southeast Rockford Groundwater Contamination Superfund Site  
Rockford, Winnebago County, Illinois  
Superfund/Technical

**Soil Component Remedial Action  
Completion Report**

Source Area 4  
Southeast Rockford Groundwater  
Contamination Superfund Site

FINAL REPORT

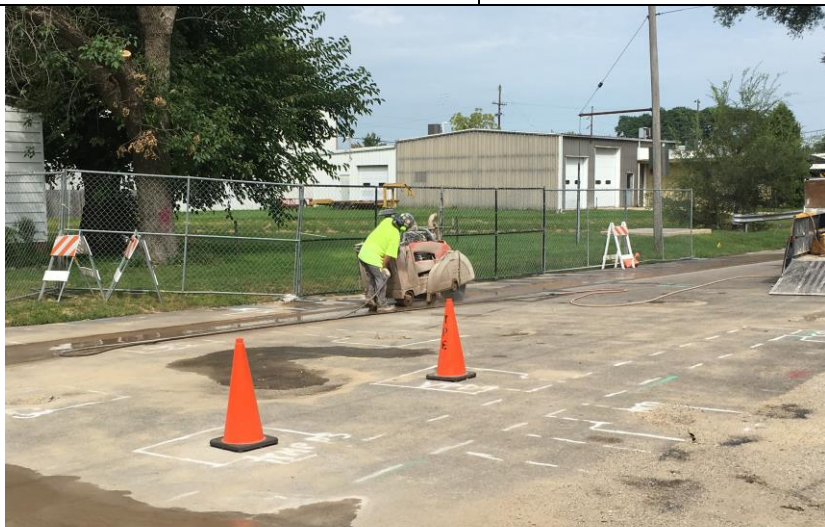
Photographic Log			Project: IEPA Rockford Area 4	Project Number: 80527
Photo No. 1	Date: 08/29/2016	Time: 1054

Direction:  Southeast				
Description:  Diamond Sawcut sawcutting trenches in Marshall St.

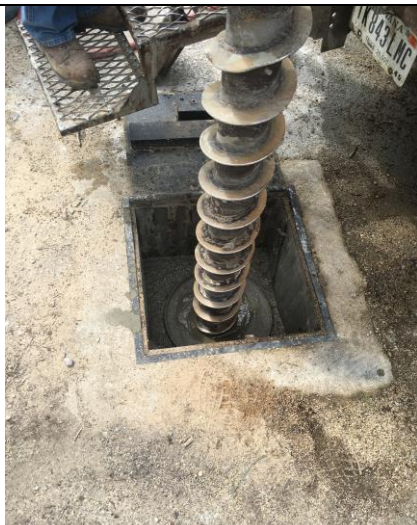
Photo No. <b>3</b>	Date: 08/29/2016	Time: 1112

Direction:			
Description:  K&S over-drilling groundwater monitoring well located on site. Well was grouted from bottom to top of casing then over-drilled to 10 feet below ground surface. Concrete was then poured into well vault and settled to 2.5 feet below ground surface.

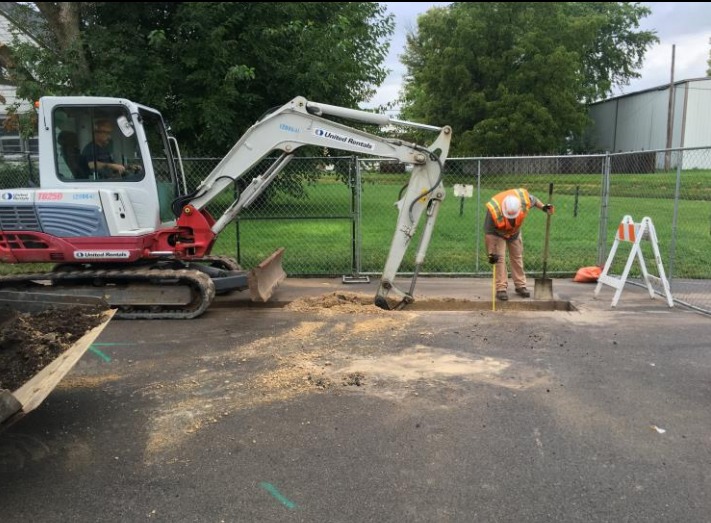
Photographic Log			Project: IEPA Rockford Area 4	Project Number: 80527
Photo No. <b>1</b>	Date: 08/30/2016	Time: 0805

Direction:				
East				
Description:				
TRS began trenching in Marshall St. starting on the Southeast corner and working their way to the North.

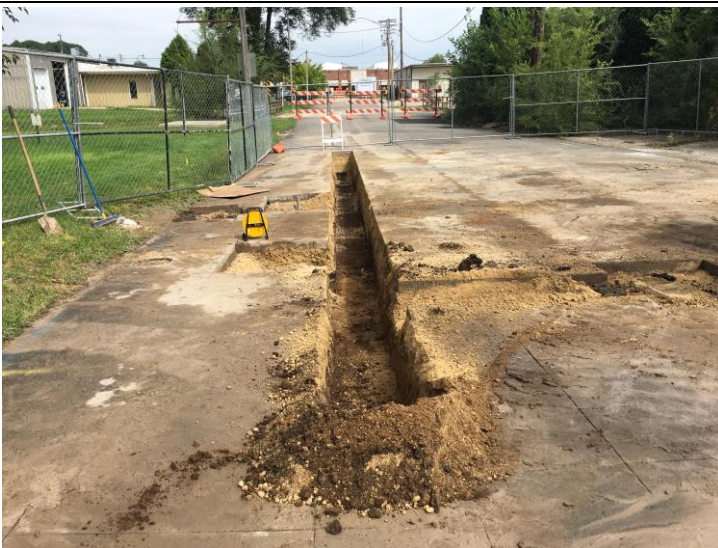
Photo No. <b>2</b>	Date: 08/30/2016	Time: 1109
Direction:  South		
Description:  TRS excavated down to between 25" and 30" below ground surface for cpvc pipe that connected to below ground surface electrodes, temperature monitoring points, and groundwater monitoring points.

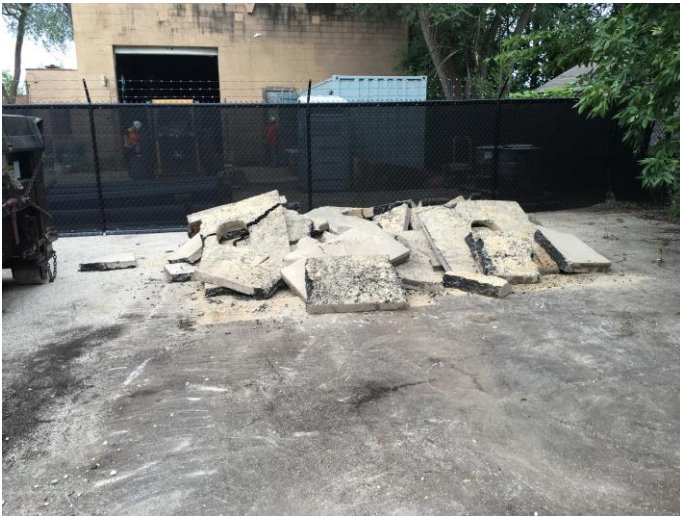
<b>Photo No.</b> <b>3</b>	<b>Date:</b> 08/30/2016	<b>Time:</b> 1650

<b>Direction:</b> South			
<b>Description:</b>  TRS stockpiled asphalt from the stop of the trenches on the southwest corner of the property. All of the asphalt will be recycled at the end of trenching activities.

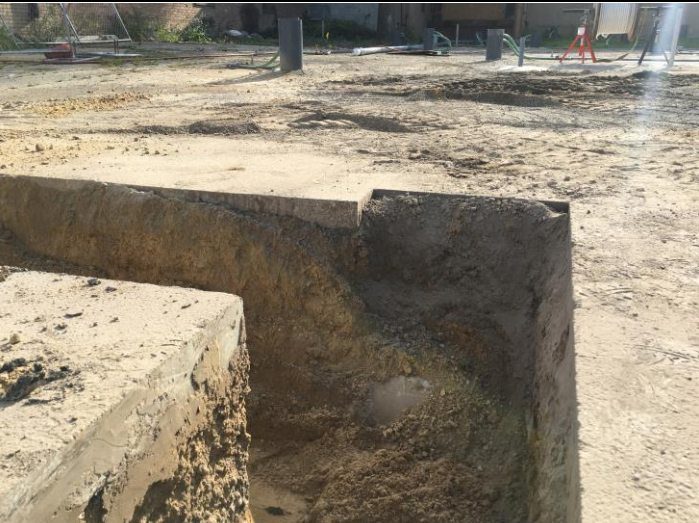
Photographic Log			Project: IEPA Rockford Area 4	Project Number: 80527
Photo No. 1	Date: 08/31/2016	Time: 00857

Direction:  East				
Description:  A stormwater pipe was encountered while digging a north-south trench between the C and D row of electrodes. After discussions, a new trench was sawcut 4 feet to the east of planned trench.

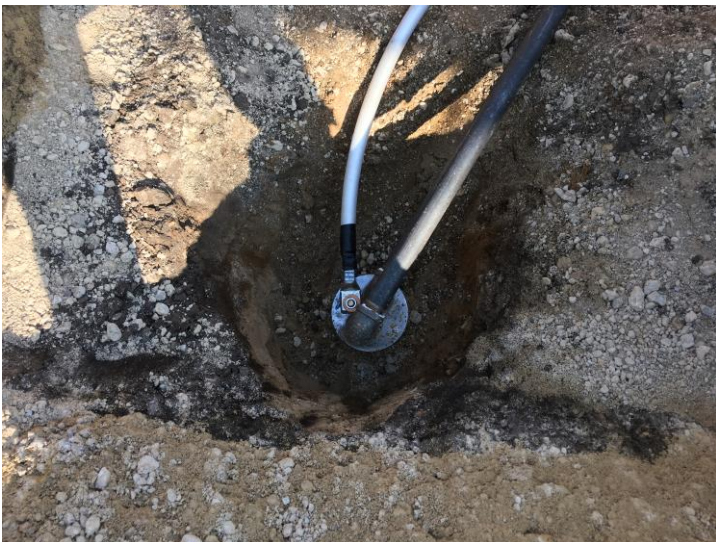
Photo No. <b>2</b>	Date: 08/31/2016	Time: 1109

Direction:  South			
Description:  Example of typical below ground electrode construction. Electrode cables were cut to desired length and then lugged at the end. The wire was stripped using a wire stripper then lugged with a long barrel lug. Luges were crimped at the end using a large wire crimper. Silicone tape and electrical tape was then applied over connection between lug and rubber sleeve.

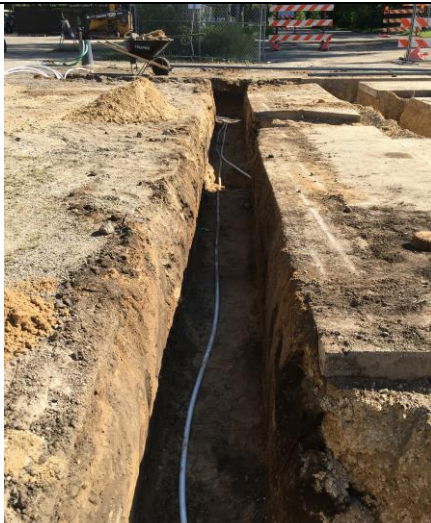
Photo No. <b>3</b>	Date: 08/31/2016	Time: 1612

Direction: South			
Description:  New north-south trench located 4 feet to the east of proposed trench. New trench was 26" wide and excavated to a depth of 25" to 30"

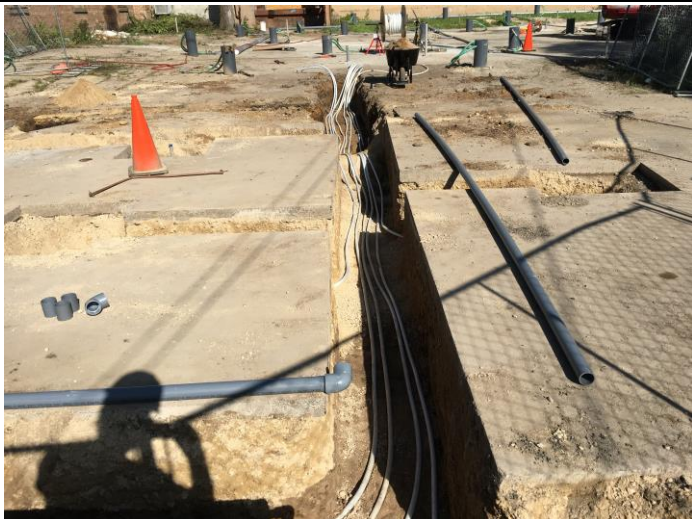
<b>Photo No.</b> <b>4</b>	<b>Date:</b> 08/31/2016	<b>Time:</b> 1533
<b>Direction:</b> East		
<b>Description:</b>  Electrode cable was ran at the bottom of the trench and exited at the southeast corner.

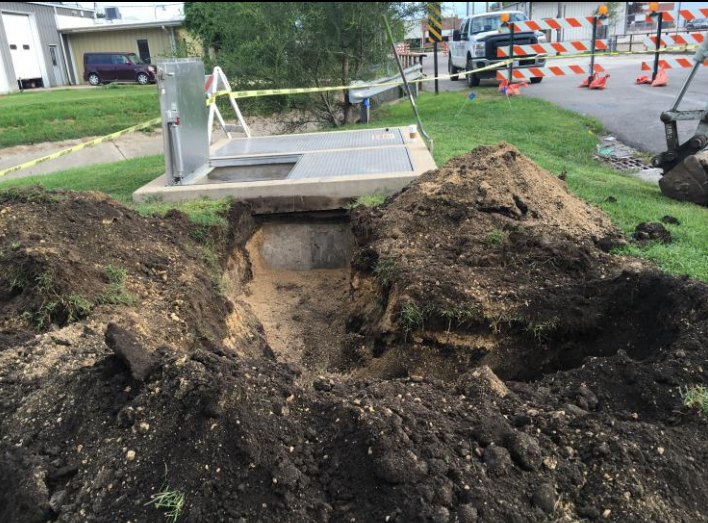
Photographic Log			Project: IEPA Rockford Area 4	Project Number: 80527
Photo No. 1	Date: 09/1/2016	Time: 0816

Direction:  North				
Description:  TRS excavated near Bodine's groundwater extraction vault so that a holes could be drilled into the side.

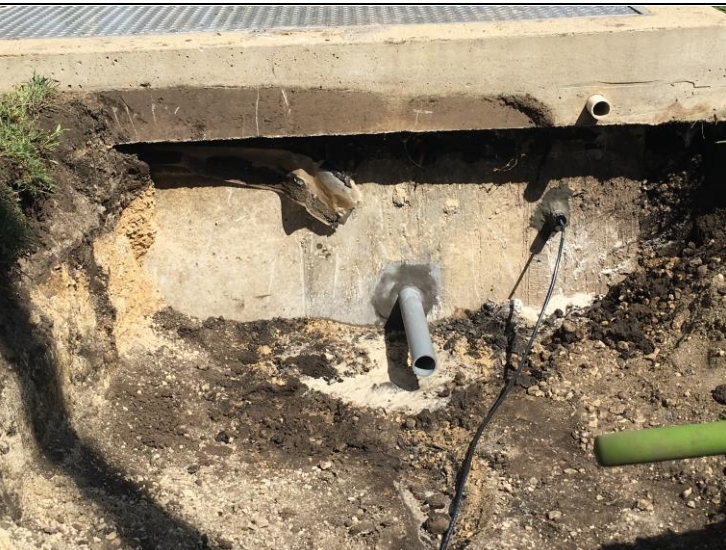
<b>Photo No.</b> <b>2</b>	<b>Date:</b> 09/1/2016	<b>Time:</b> 1125

<b>Direction:</b>  North			
<b>Description:</b>  2 holes were cored into the side of the vault. One cpvc pipe was placed for a blowdown pipe and another cpvc pipe was used for a communication cable. Both pipes were sealed into place using concrete.

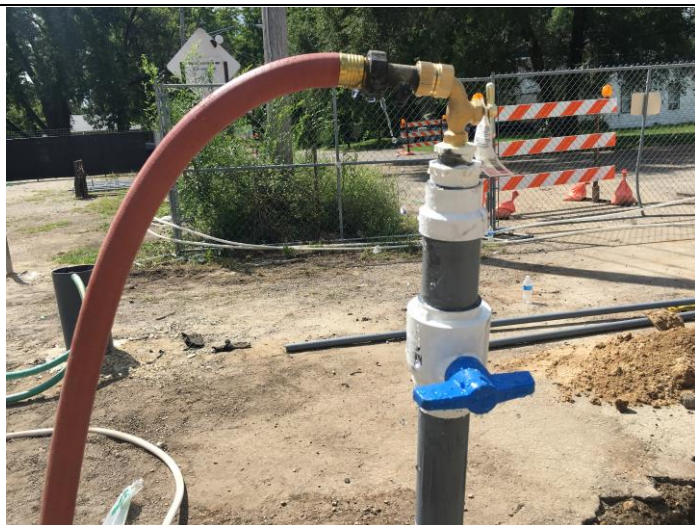
<b>Photo No.</b> <b>3</b>	<b>Date:</b> 09/1/2016	<b>Time:</b> 1156

<b>Direction:</b> South			
<b>Description:</b>  Blowdown pipe was pressure tested by placed vlaves on each side and filling the pipe with water. Internal pressure was between 40 and 70 psi.

- 0950 Randy back onsite to core  
 hole in extraction vault.  
 1001 TRS plans to pressure test  
 2" cpvc pipe to a range of  
 40-70 psi. Ball Valves were placed  
 at end that extends up on  
 property and at a distance  
 of ~4' from extraction vault.  
 Pressure test used to check  
 for leaks or breaks in line.  
 1015 Hex adapters being placed on  
 all below grade drip tubes <sup>Take</sup> <sub>onsite</sub>  
 1033 Keldorn back onsite to haul  
 another rolloff to land fill.  
 1035 Hole cored into extraction  
 vault. Concrete 6" thick, 4" hole  
 1114 Mike Jackson (Jackson welding) onsite  
 to assist w/ welding bolts on  
 electrode caps.  
 1120 TRS placing wire + <sup>temperature</sup> ~~temp~~  
 controls down TMP-D3.  
 1131 Randy (Mechanical Midwest) offsite.  
 1137 Julie CapM Smith) offsite

- 1140 TRS pressure testing blowdown tube w/ hose onsite.
- 1151 Blowdown pipe filled w/ water. No leaks.
- 1200 Pressure test complete. All copper pipe intact w/ no leaks. Andrew Schamber walks pipe to inspect if there are any visual signs of leaks & check for integrity of pipe.
- 1224 TRS starting to backfill trench near extraction vault & trench outside of fenced area in Marshall St.
- 1228 Andrew Schamber offsite.
- 1320 Andrew Schamber back onsite.
- 1340 Keldorn returns back onsite to remove 2 rolloffs.
- 1344 Electrodes B-4, B-3, B-2, C-4, VP-B-4, BWP-B4, BWP-L3 are all connected.
- 1350 Drip tube construction, consisting of copper drip tube, hex adapter, white plastic tube, and a copper 90° angle & soldered w/ flux.
- 1400 TRS breaks for lunch.
- 1410 Resumes work. Cable ran from Boline control panel through trench.

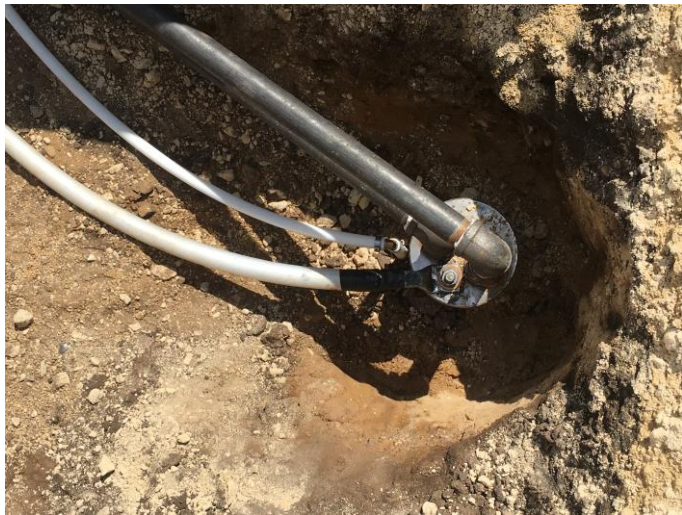
Photo No. 4	Date: 09/1/2016	Time: 1356

Direction:			
Description:  Typical electrode construction including drip tube.

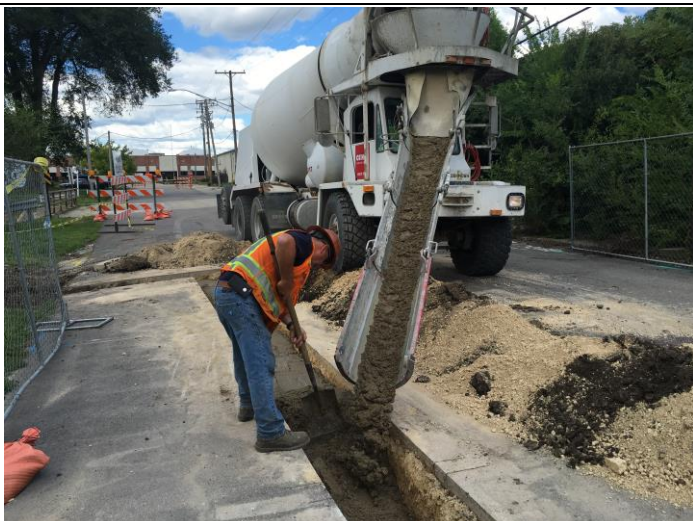
<b>Photo No.</b> <b>5</b>	<b>Date:</b> 09/1/2016	<b>Time:</b> 1423

<b>Direction:</b> North			
<b>Description:</b>  Flowable backfill (Illinois DOT specified) was placed in trench by Ozinga.

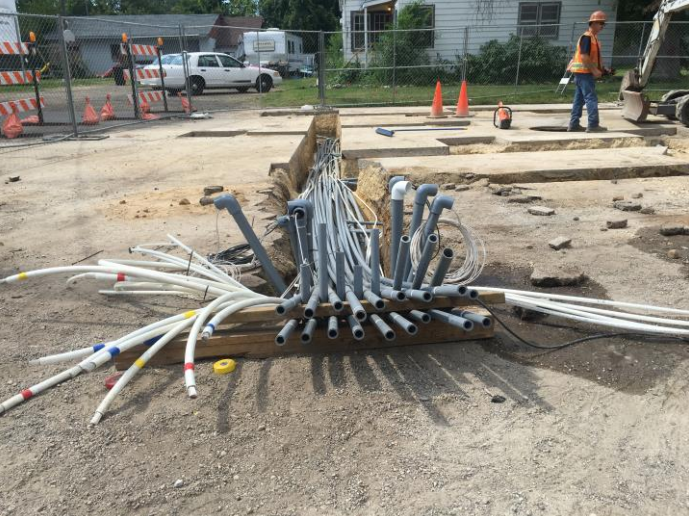
Photographic Log			Project: IEPA Rockford Area 4	Project Number: 80527
Photo No. 1	Date: 09/6/2016	Time: 1334

Direction:  West				
Description:  Exit point of underground piping.

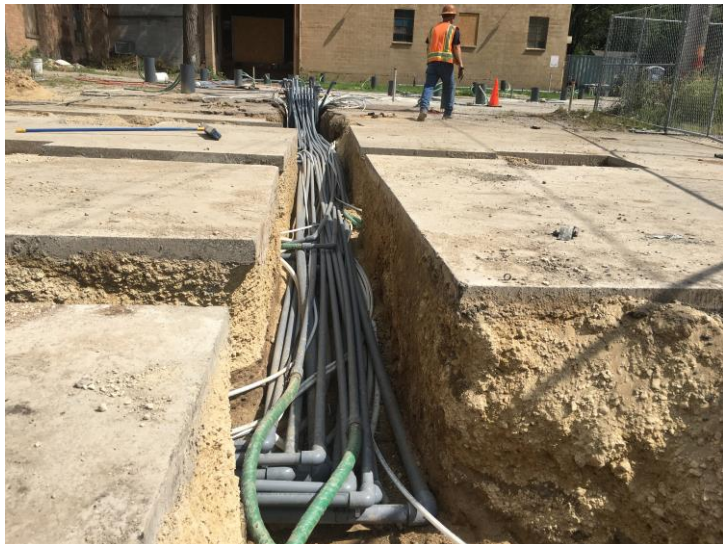
Photo No. <b>2</b>	Date: 09/6/2016	Time: 1335
Direction:  East		
Description:  East-west trench with all of the underground piping.

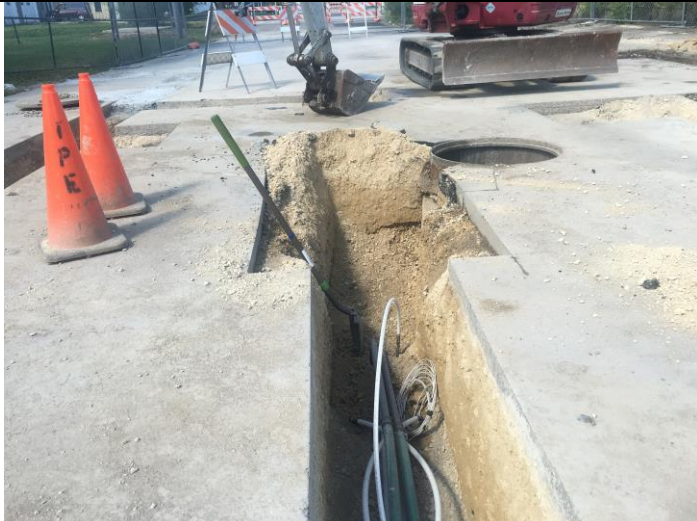
Photo No. <b>3</b>	Date: 09/6/2016	Time: 1433

Direction: North			
Description:  TRS extended trench to the North of electrode C-3 to connect with EW-3.

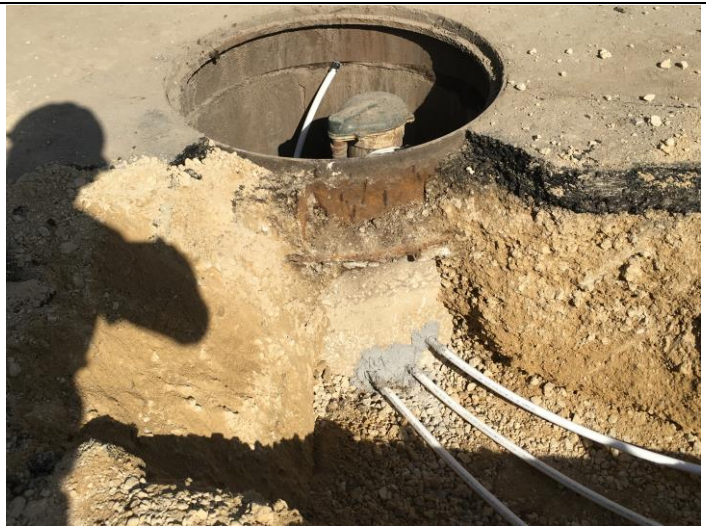
<b>Photo No.</b> 4	<b>Date:</b> 09/6/2016	<b>Time:</b> 1554
<b>Direction:</b> East		
<b>Description:</b>  3 1.25" holes were drilled into side of EW-3 vault. 2 holes for the cooling loop that will be placed in EW-3 and 1 hole for a temperature probe. Holes were sealed with hydraulic cement.

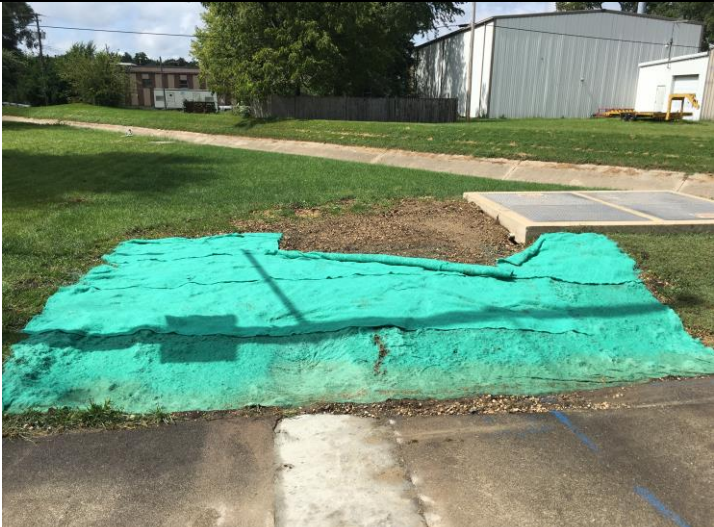
<b>Photographic Log</b>			Project: <b>IEPA Rockford Area 4</b>	Project Number: <b>80527</b>
<b>Photo No.</b> <b>1</b>	<b>Date:</b> 09/7/2016	<b>Time:</b> 1244

<b>Direction:</b> West				
<b>Description:</b>  Excavation near groundwater extraction system vault was raked, seeded, and mulch mat was placed.

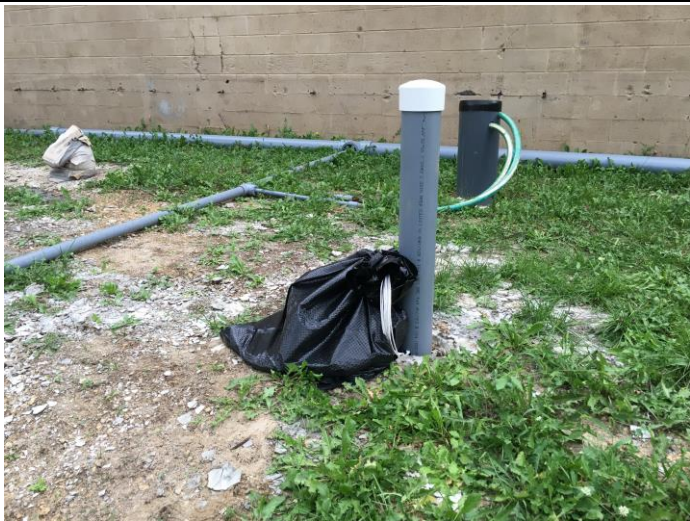
<b>Photo No.</b> <b>3</b>	<b>Date:</b> 09/7/2016	<b>Time:</b> 1605

<b>Direction:</b> East			
<b>Description:</b>  Over-sleeves were placed over temperature monitoring points (TMP). Temperature probes (RTD's) were placed down TMP's. First RTD was either placed at 3' below ground surface or 22' below ground surface and each subsequent RTD was 5' below with the last one at 37' below ground surface. Over-sleeves were placed to protect RTD's and keep water from getting into wells.

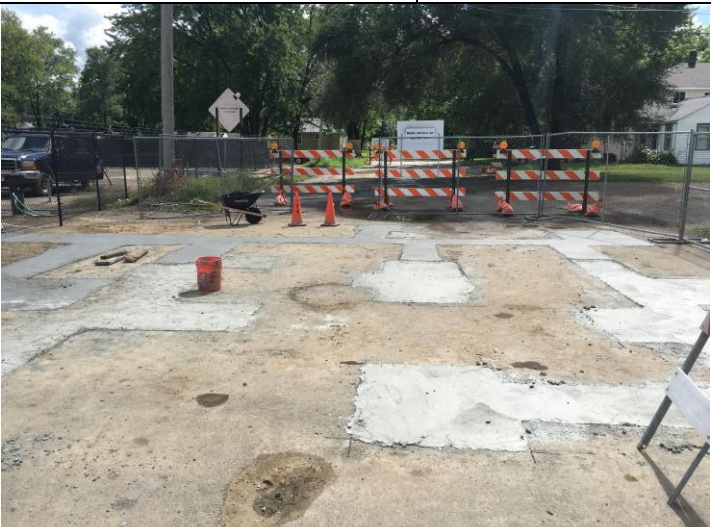
<b>Photographic Log</b>			Project: <b>IEPA Rockford Area 4</b>	Project Number: <b>80527</b>
<b>Photo No.</b> <b>1</b>	<b>Date:</b> 09/8/2016	<b>Time:</b> 1356

<b>Direction:</b> South				
<b>Description:</b>  Concrete was brought onto the site and poured by Ozinga. TRS used concrete floats to smooth the concrete out by hand.

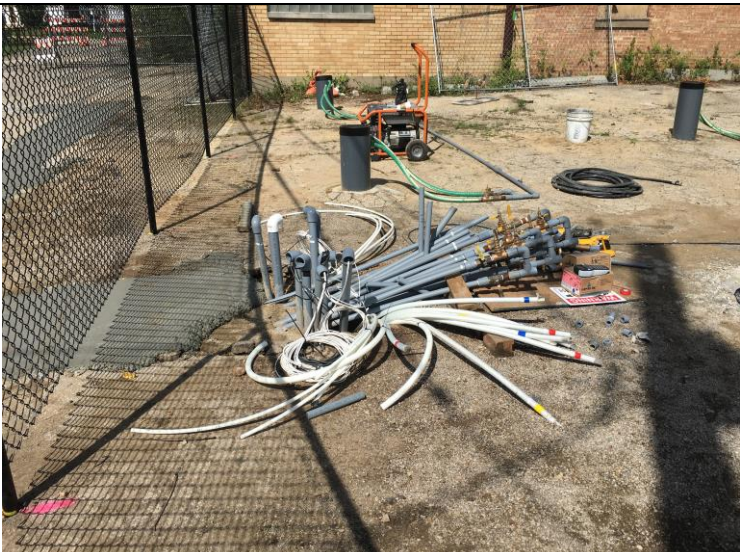
<b>Photo No.</b> <b>2</b>	<b>Date:</b> 09/8/2016	<b>Time:</b> 1409

<b>Direction:</b> North				
<b>Description:</b>  Concrete was poured up to the exit point of all of the pipes and cables coming from the trench. It was poured and the fence set approximately 3 feet away so someone couldn't reach in and grab anything on site.

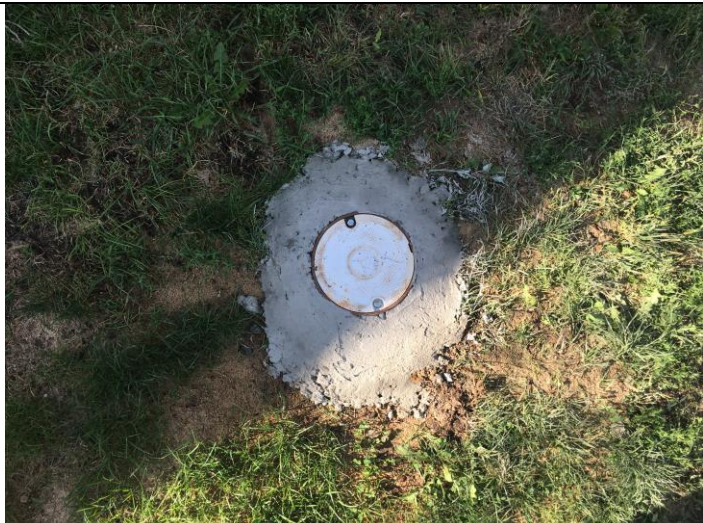
<b>Photo No.</b> <b>3</b>	<b>Date:</b> 09/8/2016	<b>Time:</b> 1629

<b>Direction:</b> N/A				
<b>Description:</b>  TRS shoveled concrete around the vault set over VP-C2.

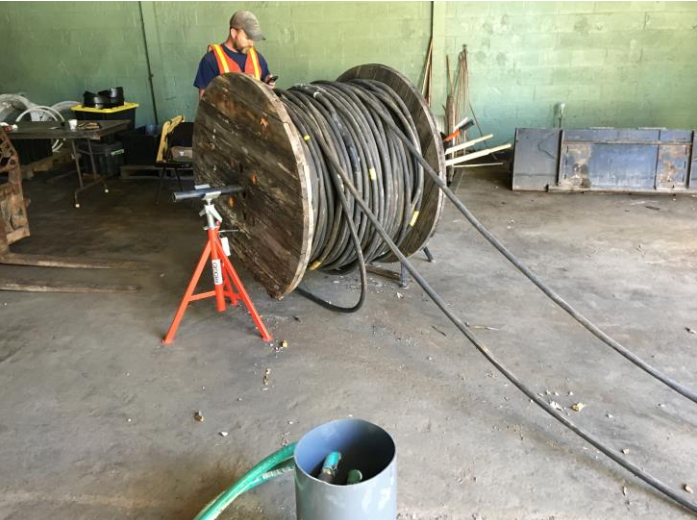
Photographic Log			Project: IEPA Rockford Area 4	Project Number: 80527
Photo No. 1	Date: 09/12/2016	Time: 1039

Direction:  East				
Description:  Type W 350 cable was delivered on spools. TRS unspooled the cable to disconnect the various lengths of cable.

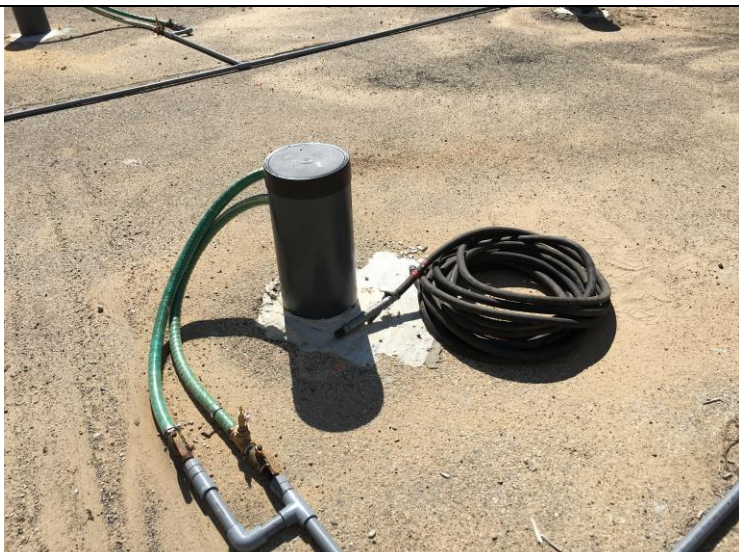
Photo No. 2	Date: 09/12/2016	Time: 1357

Direction:  Northwest			
Description:  Cable was drug to the appropriate electrode and coiled next to it until it was time to land the cable on the electrode and on the PCU.

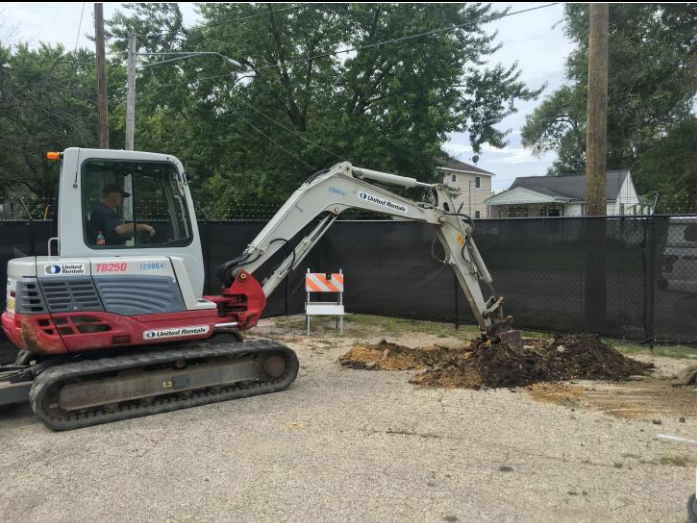
Photographic Log			Project: IEPA Rockford Area 4	Project Number: 80527
Photo No. 1	Date: 09/13/2016	Time: 1114

Direction:  Southwest				
Description:  TRS used a mini excavator to dig trench for conduit that will run from ComED's power pole, underground, and up into the site inside of the fence.

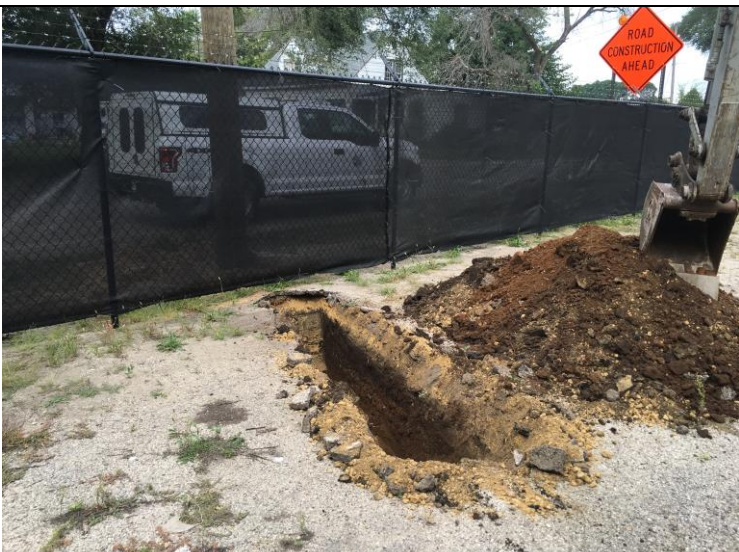
Photo No. <b>2</b>	Date: 09/13/2016	Time: 1117
Direction:  West		
Description:  TRS trenched to a depth of 3' below ground surface with a length of 10' and a width of 2'

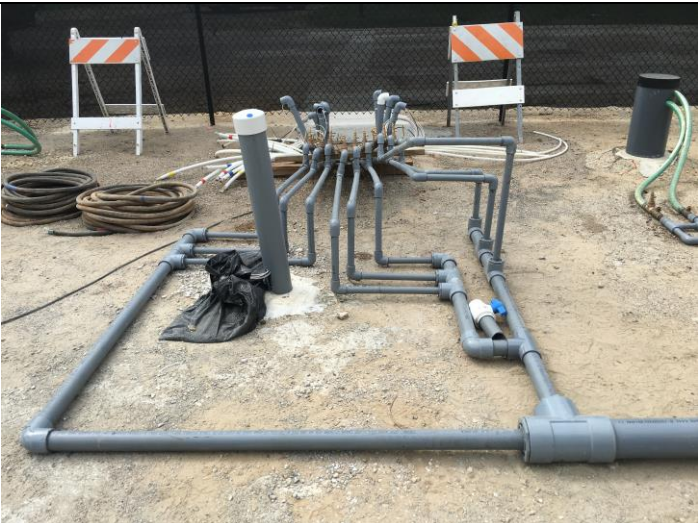
Photo No. <b>3</b>	Date: 09/13/2016	Time: 1413

Direction: West			
Description:  TRS completed the recovery piping for the underground electrodes in Marshall St.

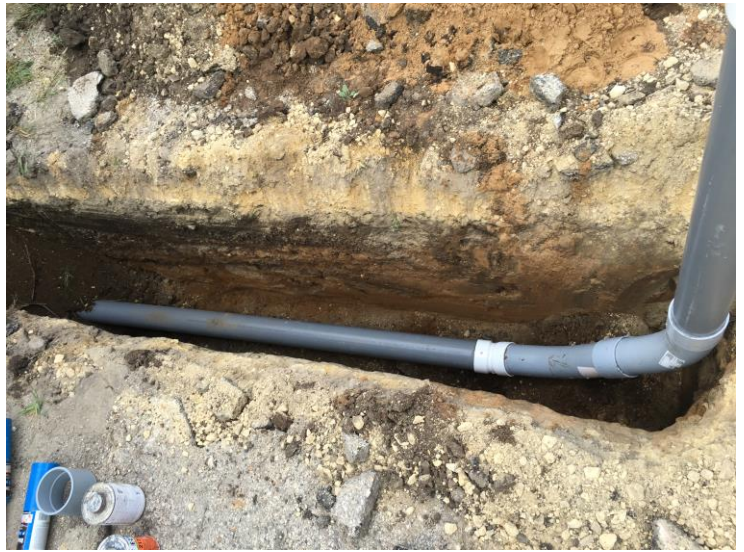
<b>Photo No.</b> <b>4</b>	<b>Date:</b> 09/13/2016	<b>Time:</b> 1618
<b>Direction:</b>  N/A		
<b>Description:</b>  4" CPVC was used as conduit for cable running from power pole to PCU. The pipe was laid on the bottom of the trench (approximately 3' below ground surface).

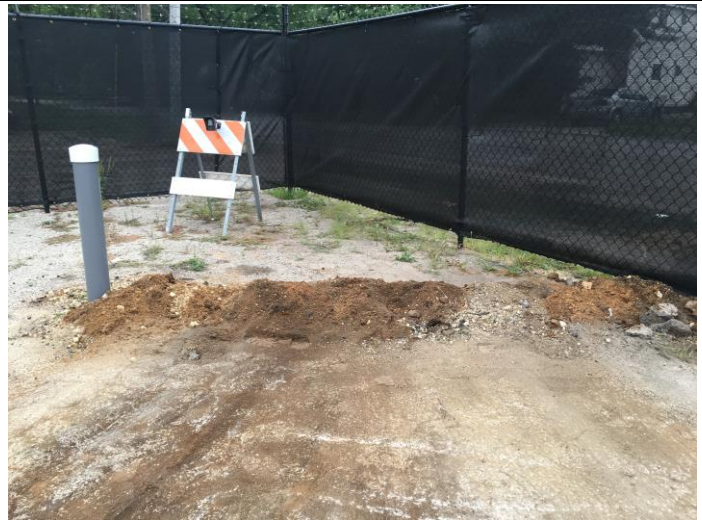
<b>Photo No.</b> <b>5</b>	<b>Date:</b> 09/13/2016	<b>Time:</b> 1643
<b>Direction:</b> Southwest		
<b>Description:</b>  The trench was backfilled with native soil.

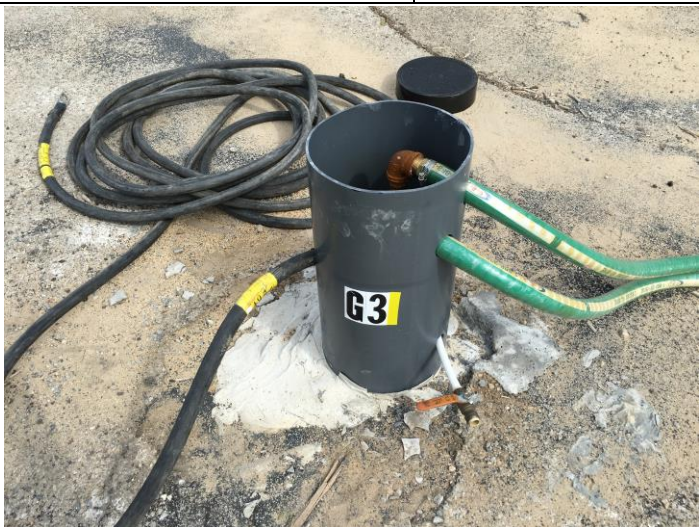
<b>Photographic Log</b>			Project: <b>IEPA Rockford Area 4</b>	Project Number: <b>80527</b>
<b>Photo No.</b> <b>1</b>	<b>Date:</b> 09/14/2016	<b>Time:</b> 1110

<b>Direction:</b>  N/A				
<b>Description:</b>  TRS drilled holes into the side of the electrode over sleeve so that the electrode cable could be connected to the electrode head.

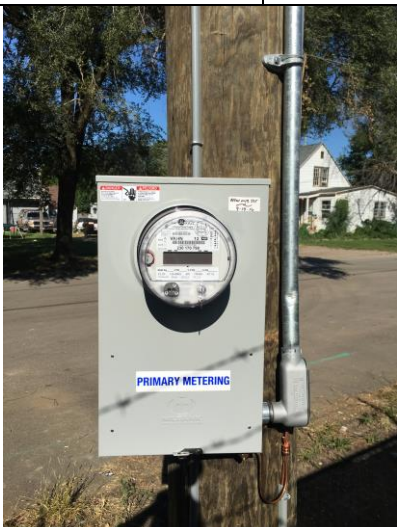
Photographic Log			Project: IEPA Rockford Area 4	Project Number: 80527
Photo No. 1	Date: 09/19/2016	Time: 0954

Direction:  N/A				
Description:  MKD Electric installed an electrical meter on ComED's power pole.

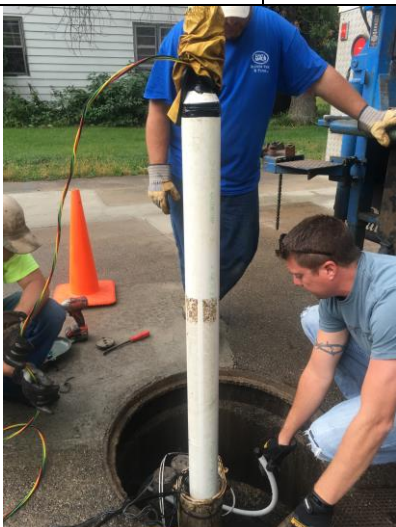
Photographic Log			Project: IEPA Rockford Area 4	Project Number: 80527
Photo No. 1	Date: 09/21/2016	Time: 0928

Direction:				
West				
Description:				
Bodine pulled the pump and shroud out of Extraction Well 3 to be cleaned. TRS plans to install their cooling loop while the pump is out of the well.

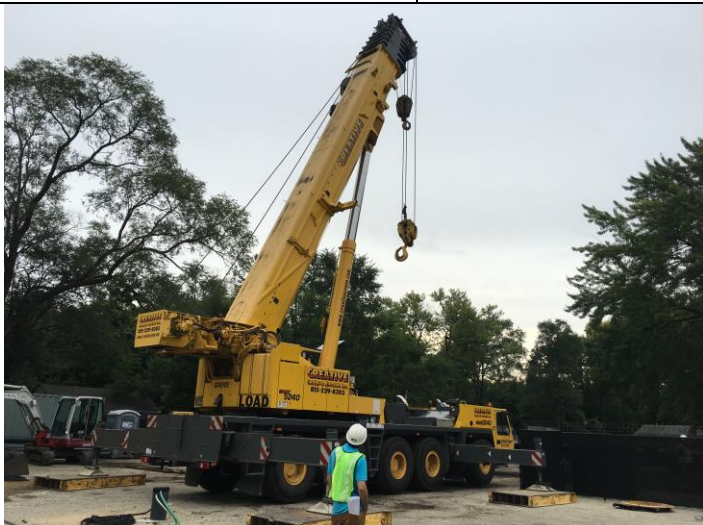
Photographic Log			Project: IEPA Rockford Area 4	Project Number: 80527
Photo No. 1	Date: 09/22/2016	Time: 0915

Direction:  Southeast				
Description:  Creative Crane and Rigging setting up the crane before the equipment arrives on site.

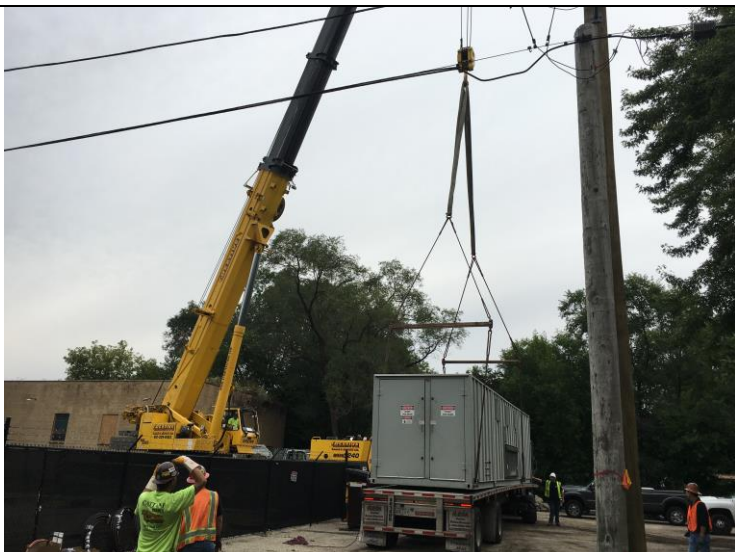
Photo No. <b>2</b>	Date: 09/22/2016	Time: 1027
Direction:  East		
Description:  PCU arrives to the site via semi-truck. Creative used two straps to lift the PCU up and over the fence and place it on site.

A photograph showing a yellow crane lifting a large, grey, rectangular metal enclosure (PCU) from the back of a semi-truck. The crane is positioned on the left side of the frame, and the PCU is suspended in the air by two straps. The semi-truck is parked on a dirt or gravel surface. In the foreground, two workers wearing safety vests are visible, one looking up at the PCU. A utility pole is on the right side of the frame. The background shows trees and a building.

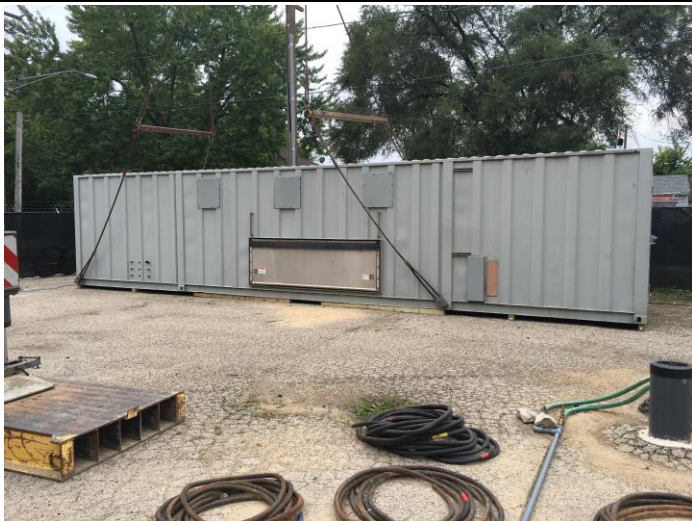
Photo No. <b>3</b>	Date: 09/22/2016	Time: 1039

Direction: West			
Description:  The PCU was placed over the conduit coming up at the trench and placed on 4X4's that were used to support the bottom as well as raise the PCU above the ground.

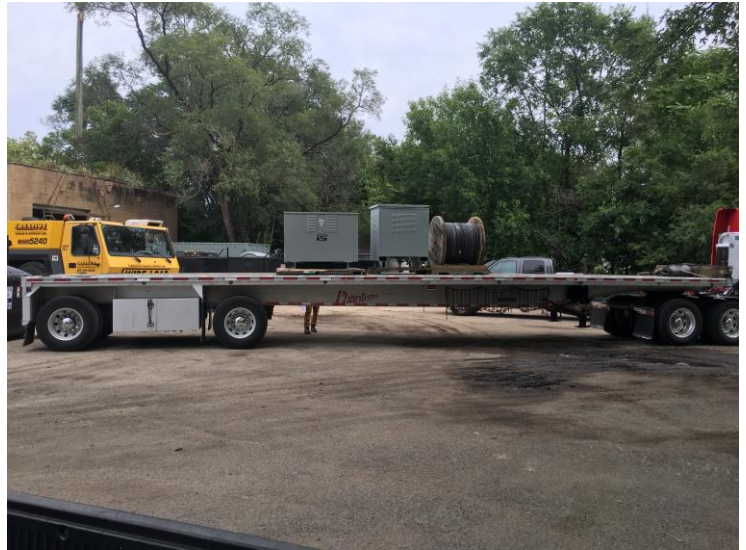
<b>Photo No.</b> <b>4</b>	<b>Date:</b> 09/22/2016	<b>Time:</b> 1306
<b>Direction:</b>  Northeast		
<b>Description:</b>  2 auto transformers (ATX-1 and ATX-3) as well as a spool of Type W 350 cable was delivered via semi-truck.

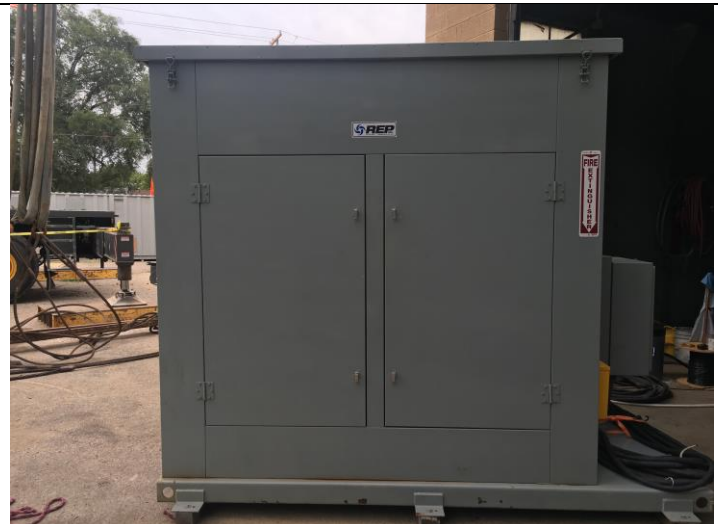
<b>Photo No.</b> <b>5</b>	<b>Date:</b> 09/22/2016	<b>Time:</b> 1308
<b>Direction:</b>  Northwest		
<b>Description:</b>  The blower was delivered via semi and placed with the crane. Eventually it will be pushed into the building so muffle the sound for the residents next door.

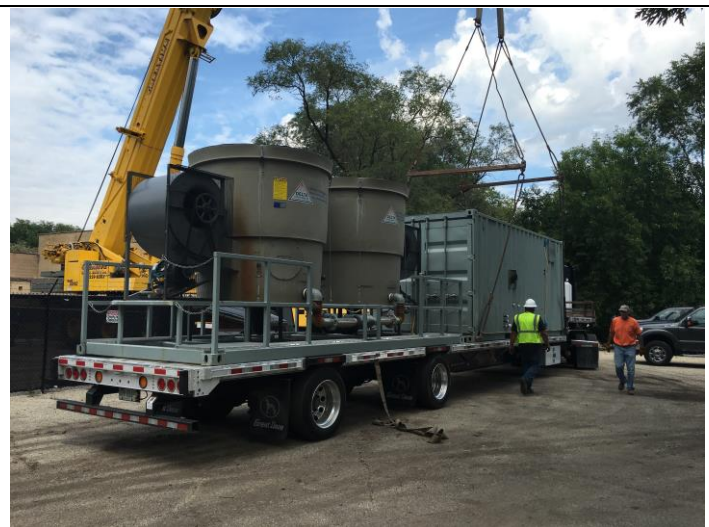
<b>Photo No.</b> <b>6</b>	<b>Date:</b> 09/22/2016	<b>Time:</b> 1525
<b>Direction:</b>  Northeast		
<b>Description:</b>  The condenser unit and cooling towers arrived on site via semi-truck. Creative crane use the same technique to lift the condenser unit as they did the PCU.

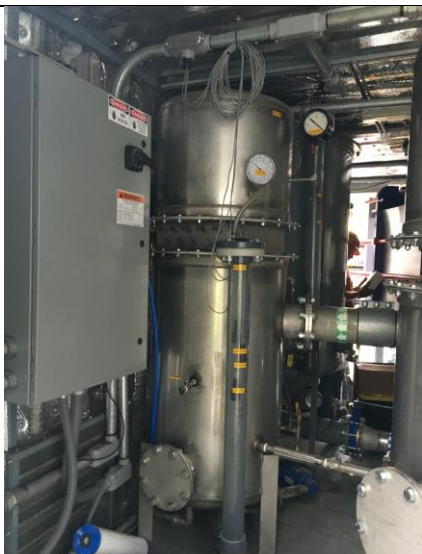
<b>Photo No.</b> <b>7</b>	<b>Date:</b> 09/22/2016	<b>Time:</b> 1535

<b>Direction:</b>  West			
<b>Description:</b>  Control panel and primary knockout tank inside of the condenser unit.

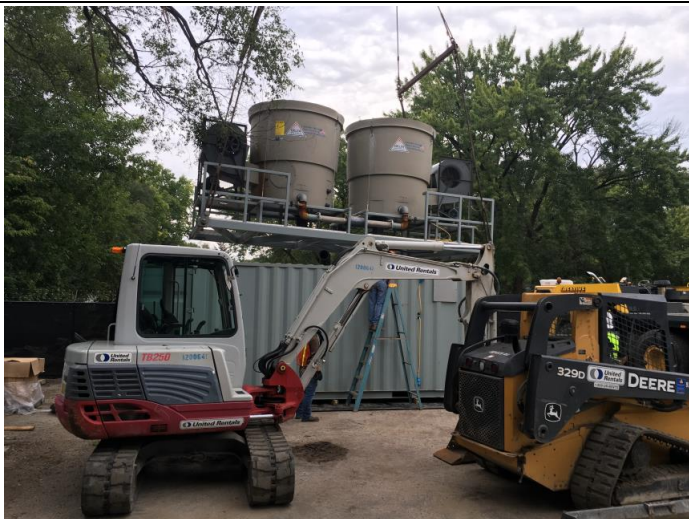
Photo No. 8	Date: 09/22/2016	Time: 1543

Direction: South			
Description:  The cooling towers were placed on top of the condenser unit by Creative Crane.

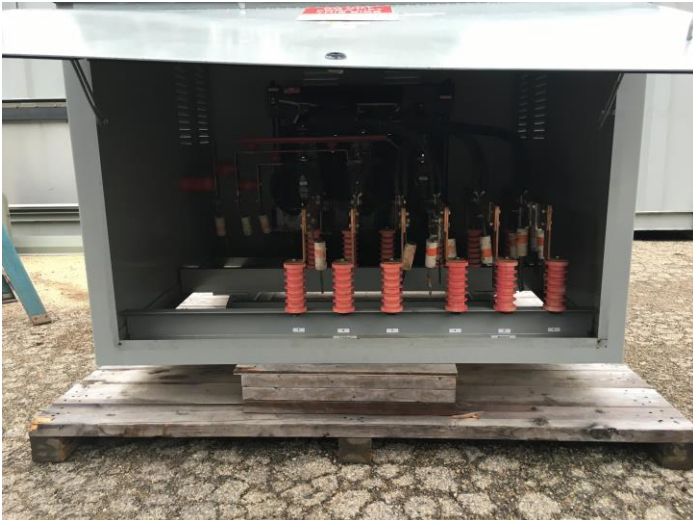
Photographic Log			Project: IEPA Rockford Area 4	Project Number: 80527
Photo No. 1	Date: 09/23/2016	Time: 0849

Direction:  West				
Description:  Inside of the panel on ATX-1.

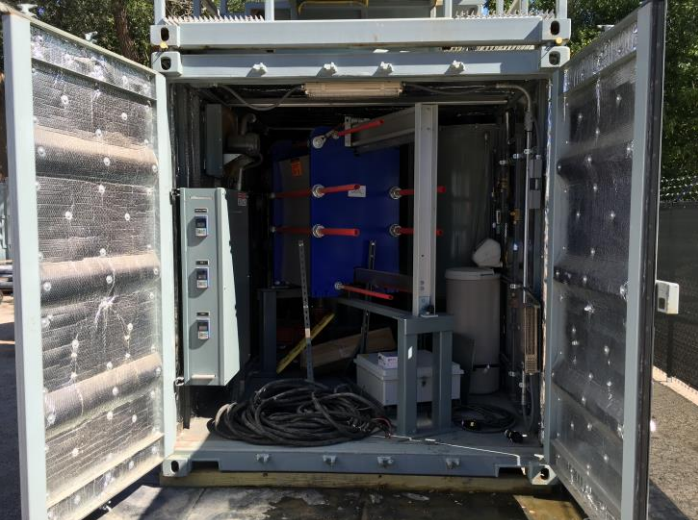
Photographic Log			Project: IEPA Rockford Area 4	Project Number: 80527
Photo No. <b>1</b>	Date: 09/26/2016	Time: 1330

Direction:				
East				
Description:				
Control panel and water softener inside of the condenser unit.

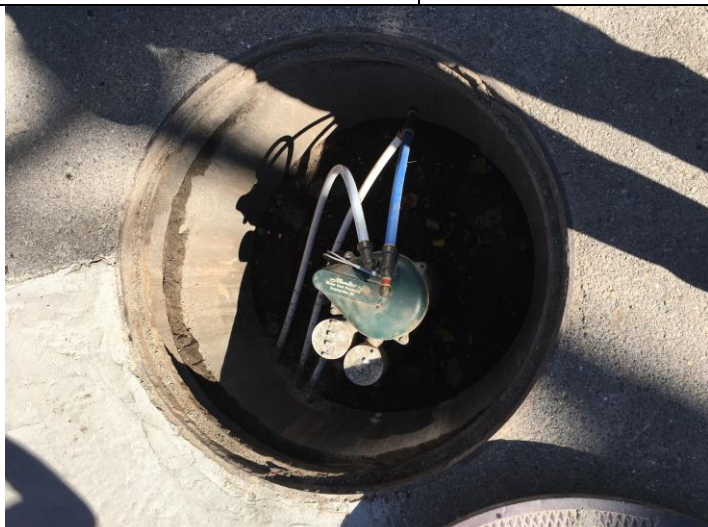
Photographic Log			Project: IEPA Rockford Area 4	Project Number: 80527
Photo No. 1	Date: 09/27/2016	Time: 1127

Direction:  N/A				
Description:  Drip loop was installed in EX-003 to 42' below ground surface and consisted of 3/4" PEX tubing to 35' and 1/2" PEX tubing from 35' to 42'. The tubing was brought through the plastic cover and into the manhole.

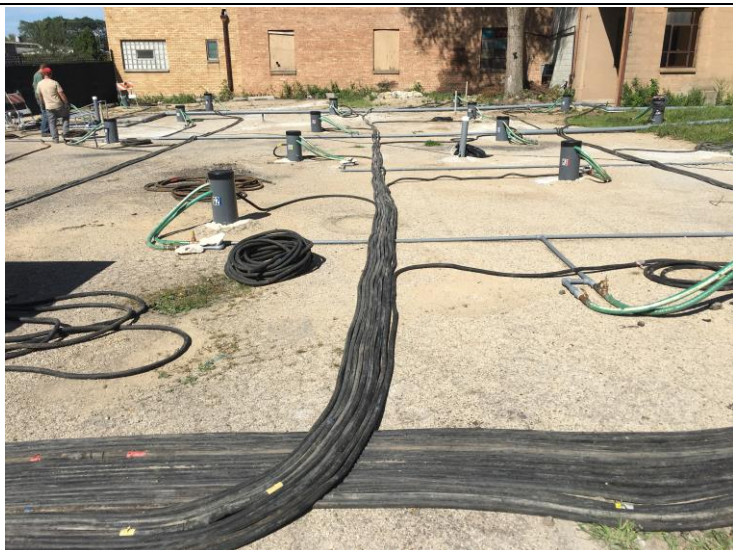
Photo No. <b>2</b>	Date: 09/27/2016	Time: 1354
Direction:  North		
Description:  Electrode cable was brought down between electrode rows. This electrode run is between row "G" and "H".

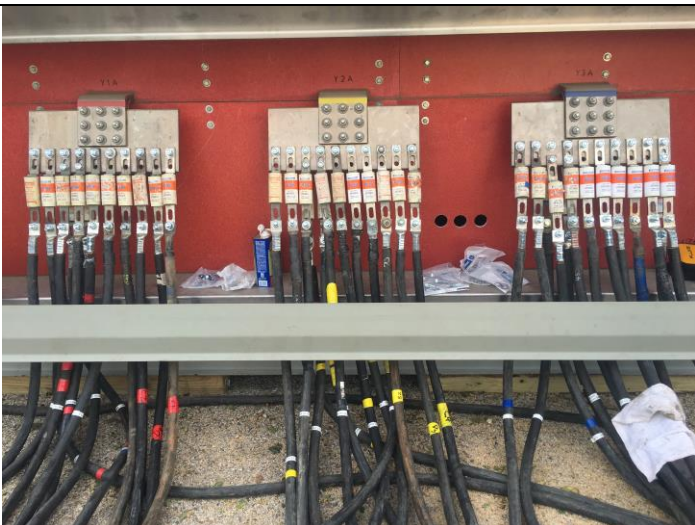
Photo No. <b>3</b>	Date: 09/27/2016	Time: 1606

Direction: West			
Description:  All electrode cables attached to Amp-Traps and attached to phase plates on the PCU.

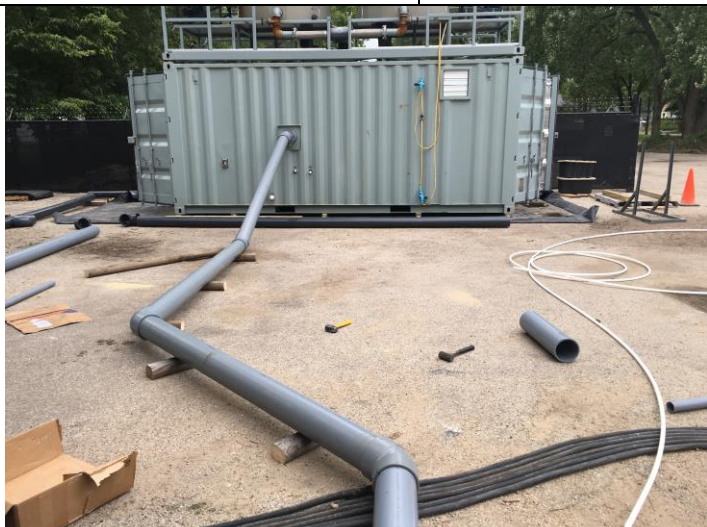
Photographic Log			Project: IEPA Rockford Area 4	Project Number: 80527
Photo No. <b>1</b>	Date: 09/28/2016	Time: 1113

Direction:				
South				
Description:				
The 6" CPVC recovery pipe runs along the building and angles up at a 22 degree angle into the condenser unit.

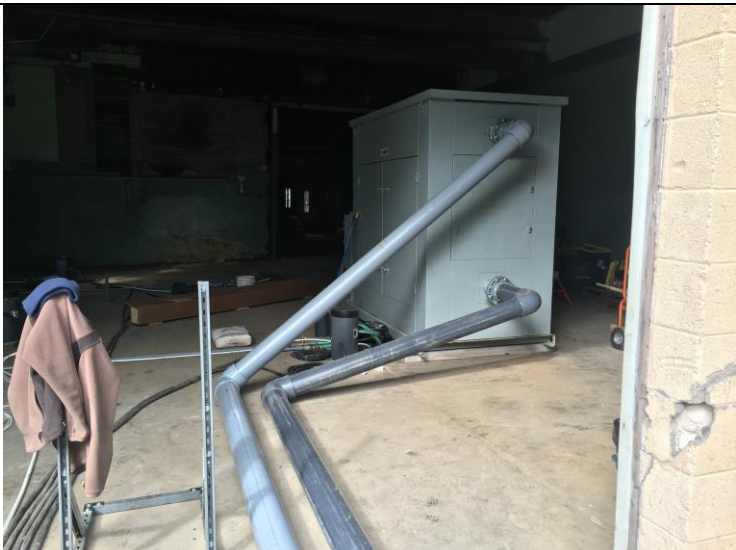
Photo No. <b>2</b>	Date: 09/27/2016	Time: 1459

Direction:			
North			
Description:			
6" PVC pipe goes in to the blower (bottom) and 6" CPVC pipe comes out (top).

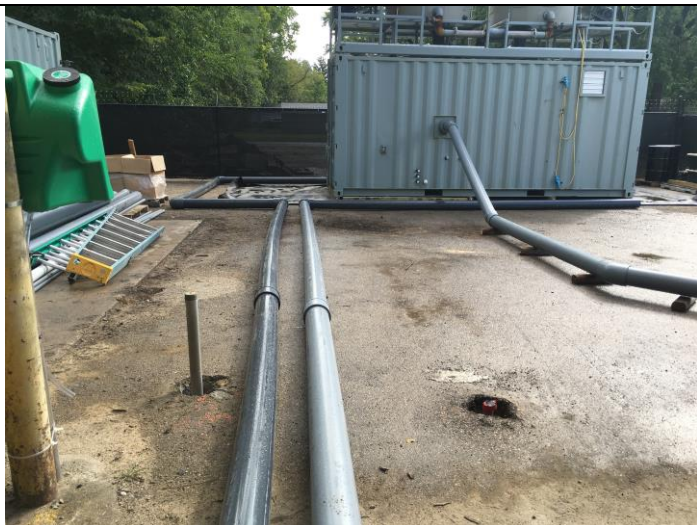
Photo No. <b>3</b>	Date: 09/27/2016	Time: 1459

Direction: South			
Description:  6" PVC pipe runs out of the south side of the condenser to the blower then from the blower will be connected to the VGAC vessel when it arrives.

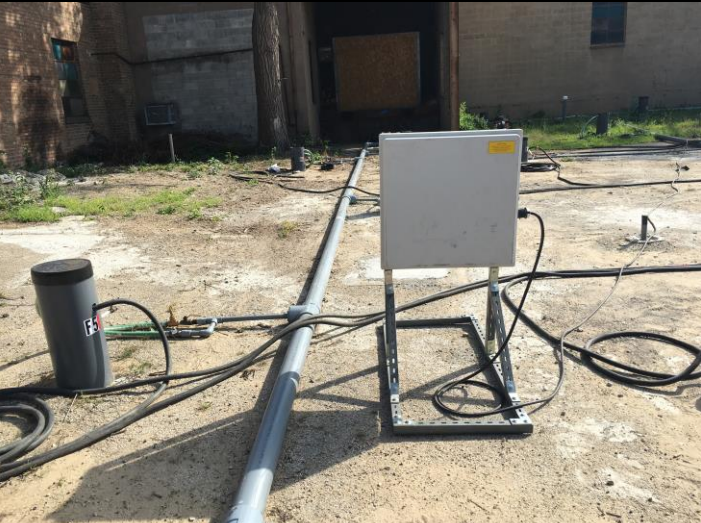
Photographic Log			Project: IEPA Rockford Area 4	Project Number: 80527
Photo No. 1	Date: 09/29/2016	Time: 1052

Direction:				
East				
Description:				
One of two RTD (temperature control boxes) placed on site. All of the temperature sensors are connected to one of the two boxes which then connects to the site computer on site.

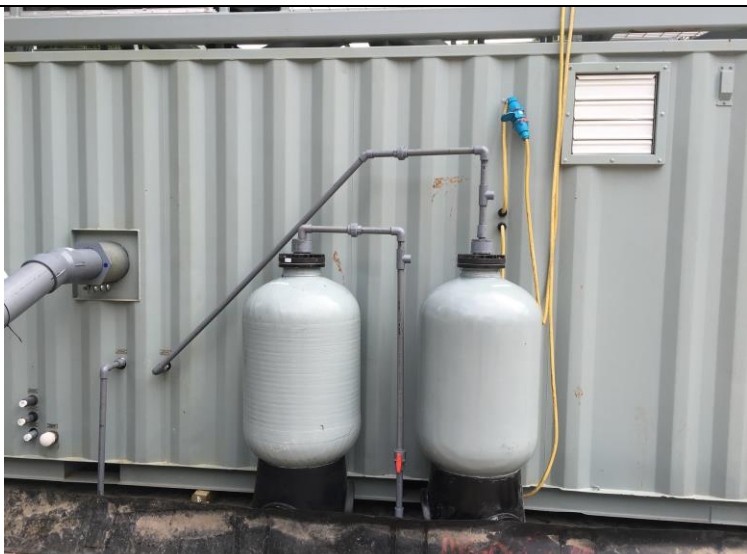
Photo No. <b>2</b>	Date: 09/29/2016	Time: 1639
Direction:  South		
Description:  The primary (left) and secondary (right) LGAC (Liquid Granular Activated Carbon) vessels were hard piped to the condenser unit using 1" CPVC pipe.
